# Column Pump Refurbishment

<b>Industry</b>	Power Generation
<b>Date</b>	April 2018
<b>Substrate</b>	Cast Iron Pump
<b>Products</b>	<p><i>Internals</i>, <a href="#">Chem-TECT™ RB 364</a> a glass flake filled vinyl ester. <a href="#">Ceram-chem™ RP 500</a> a ceramic filled epoxy.</p> <p><i>Externals</i>, <a href="#">Epo-chem™ RS 500P</a> a surface and moisture tolerant primer. <a href="#">Epo-chem™ RA 500M</a> a glass flake filled epoxy.</p>
<b>Environment</b>	Ambient Salt Water
<b>Challenge</b>	Chemco were brought in to carry out pump refurbishment after catastrophic failure of bearing causing the impeller to wear through the casing
<b>Chemco's Solution</b>	Refurbish pump lining to extend service life using glass flake filled coatings, then top coated using RP 500 to improve fluid flow efficiency.
<b>Scope</b>	<p>Abrasive blast to AS.1627.4 to class 2.5</p> <p>Masking and protection of critical tolerances and bush area on flange.</p> <p>Pit filled to allow smooth transition and prevent coating defects</p> <p>Sand smooth where necessary &amp; application of RB364 to 1,000µm</p> <p>Internal &amp; external holiday testing to ensure coating continuity using the required voltage to sui

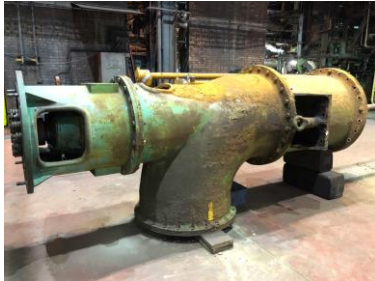
Condition in situ
