Client: <i>Northern Marine Management</i>	Industry: <i>Marine</i>
Vessel: <i>Crude Oil Tanker</i>	Date: <i>March 2015</i>
Location: <i>Antwerp, Belgium</i>	Product: <i>Epo-chem™ RS 500P</i>

The ballast tanks on-board the Crude Oil Tanker, which had previously been coated by one of the leading coating companies, were showing signs of corrosion damage. Over 30,000m² required to be patch repaired.

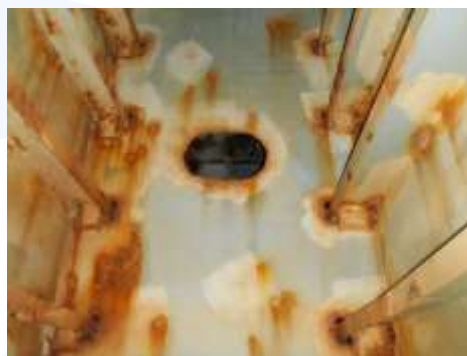
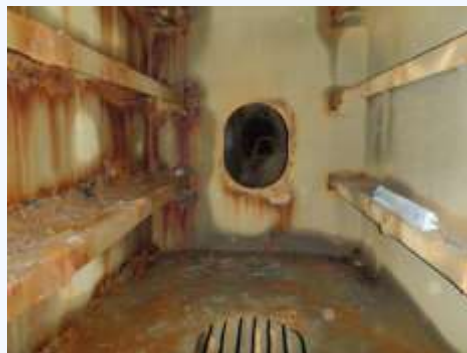
- Nos. 1-2 Original Conditions
- No. 3 After Surface Preparation

High pressure water washing was used as the main surface preparation method, with inaccessible areas mechanically prepared. All edges, welds and inaccessible areas were stripe coated, followed by one touch up coat of **solvent-free, wet & rust tolerant epoxy Epo-chem™ RS 500P**.

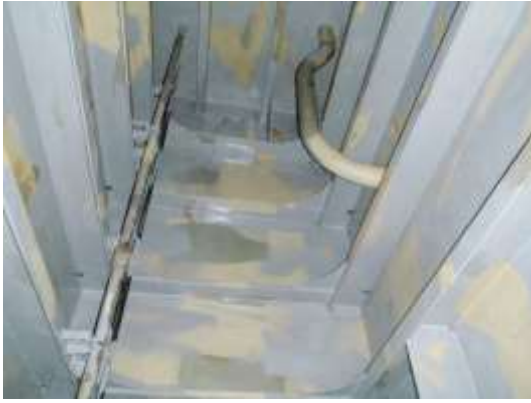
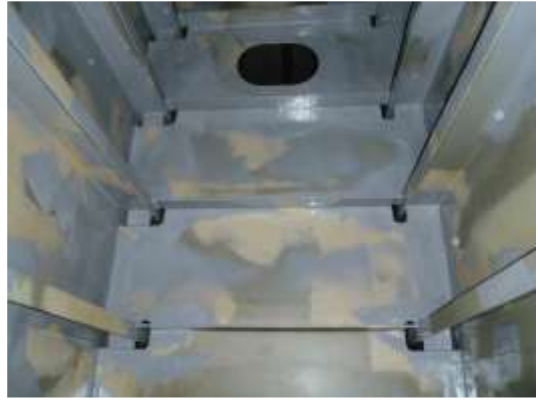
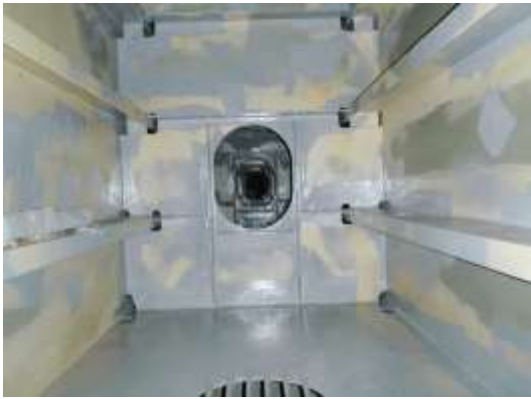
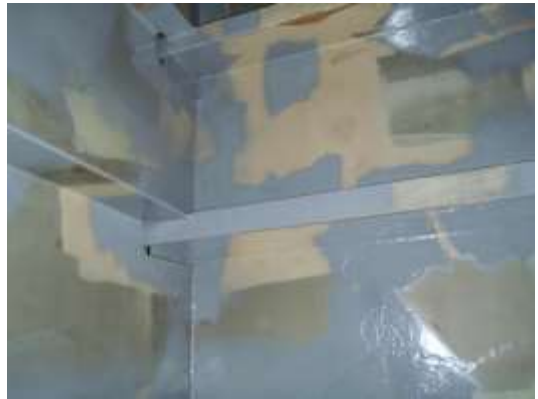
- Nos. 4-7 Completed Application

The unique characteristics of **Epo-chem™ RS 500P** allowed the system to be applied with no compatibility issues. Significant time and cost savings were achieved by utilising this **Chemco** system.
