RA 500 series to Column Pump

Industry Petrochemical
Date April 2011
Substrate Column pump
Products RS 500P
 RA 500 Series
 RH 500
 RP 500
Environment Storm Water, Effluent from Refinery

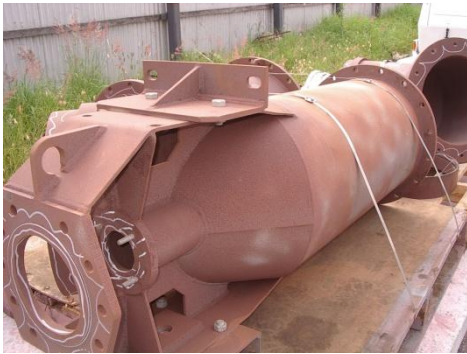
Challenge Corrosion pitting is evident in the suction bell & adjoining column. Erosion/corrosion was taking place in the wear spacer ring/housing.

Pitting and erosion in the wear spacer ring/housing

Chemco's Solution We recommend rebuilding the internal diameters affected by erosion corrosion to extend column pipe life and return pump to original efficiency.

Scope Abrasive blast to AS.1627.4 to class 2.5
 Masking and protection of critical shaft tolerances
 Pitting is filled to allow smooth transition and prevent coating defects
 Application of RA 532 internal & external
 Pitfilled areas within impeller housing to ensure smooth finish
 Application of RA 532 at a nominal thickness of 200 µm internal & external
 Application of RP500 internal
 Application of Luxathane R 'N35' external

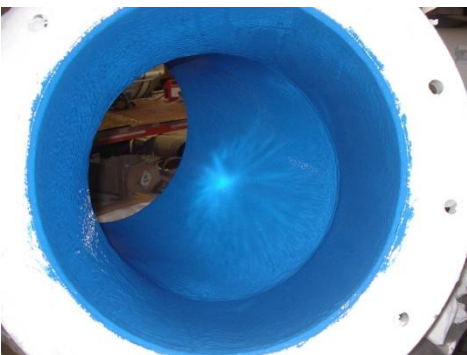
3rd coat complete

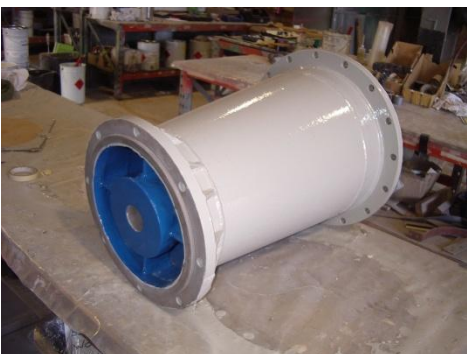
Finishing touches ready for packaging

Results The pump was rebuilt and returned to service within a week. A new replacement pump had a lead time of 16 weeks. The client was extremely happy thanks to the experienced Chemco team and the exceptional qualities of the Chemco International Range.
