Client: <i>Belgian Power Station</i>	Industry: <i>Industrial</i>
Scope: <i>Cooling Water Pump Repair</i>	Date: <i>July 2001</i>
Location: <i>Belgium</i>	Products: <i>RS 500P & RP 500</i>

The internals of a cooling water pump required to be refurbished due to excessive wear and tear.

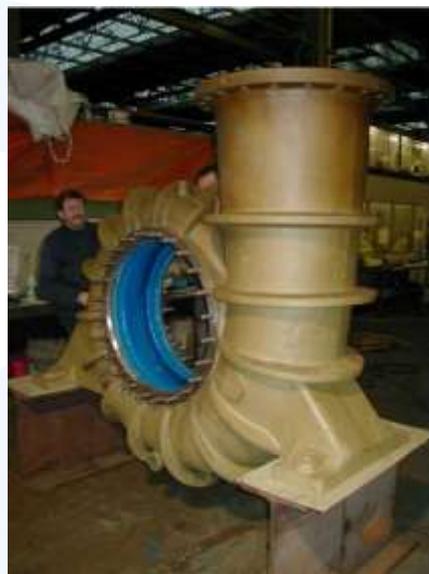
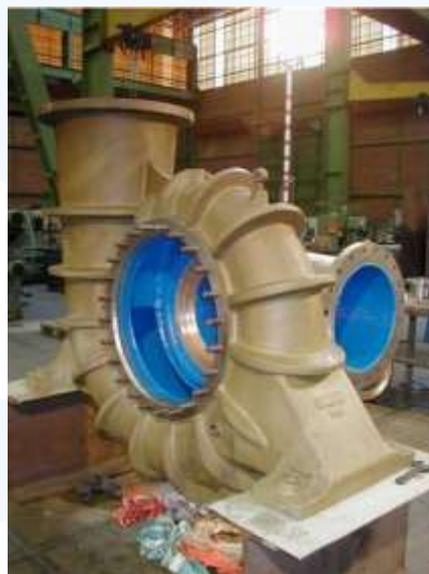
- Nos. 1 - 2 Completed application

The pump internals were abrasive blasted to Sa 2½ standard. One primer coat of **solvent-free, wet & rust tolerant Epo-chem™ RS 500P** was then applied. This was followed by one topcoat of **solvent-free, ceramic coating Ceram-chem™ RP 500**.

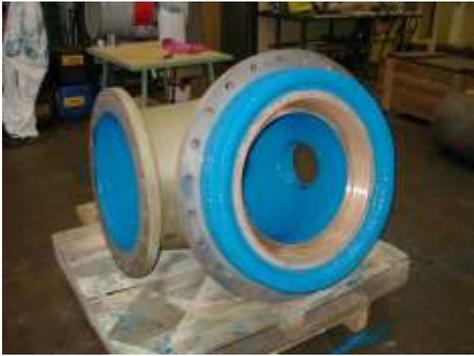
- No. 3 Completed application
- Nos. 4 - 6 After 3 years in service

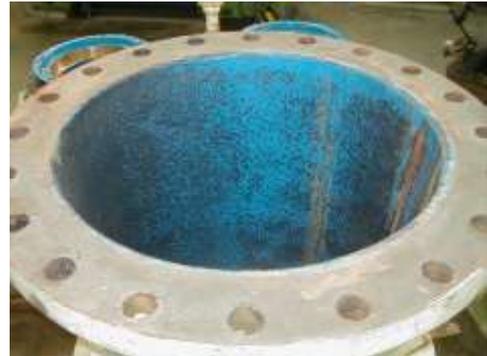
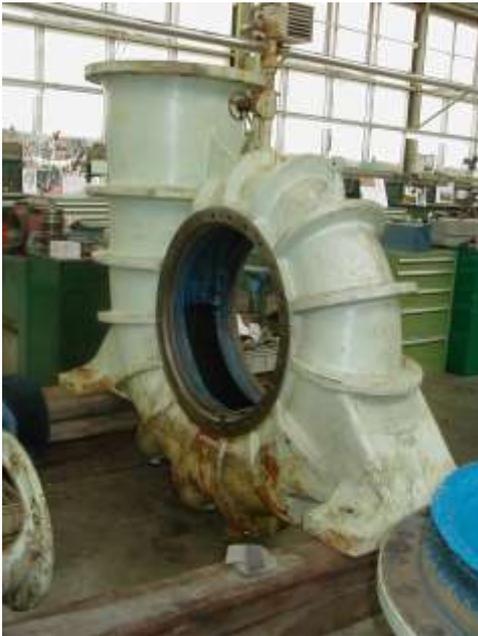
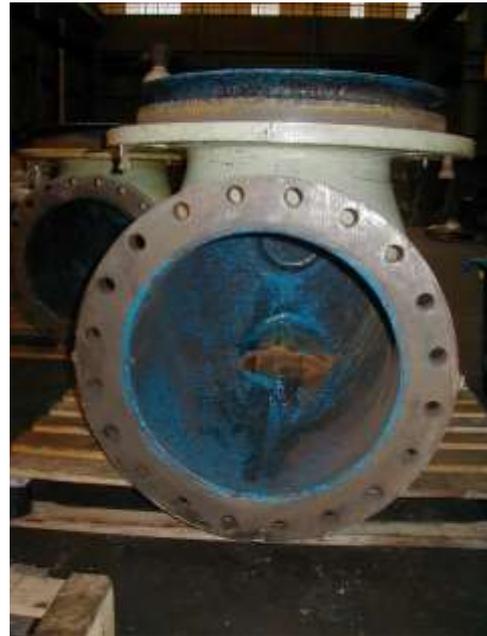
Due to other ongoing maintenance work within the vicinity, the cooling water pump was inspected after 3 years in service. The coating was found to be in perfect condition except for some mechanical damage (please see pictures 4 - 6).
