# 500 Series Oil Cooler Water Boxes

**Industry** Power Generation  
**Date** Aug 2010  
**Substrate** Cast Iron  
**Products** RS 500P Primer  
 RA 500M Glassflake filled epoxy

**Challenge** Refurbish and extend the operating life of extensively corroded, 35 year old, cooler water boxes. Deep pitting was found in many locations requiring pit filling and reinforcement using composites. Water Boxes were to be coated on site with minimal disruption to adjacent turbine hall. Prepare, coat, cure and complete in a duration of four days.

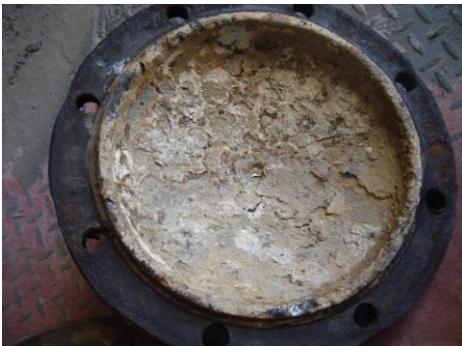
35 Year old Oil Cooler Cover

- Needle gun difficult to access areas
- Remove graphitised materials with high pressure water blast at 20,000psi
- Assess damage and apply one coat of RS 500P integrated with a fibreglass matting to cope with low pressure
- Application of two coats of RA 532

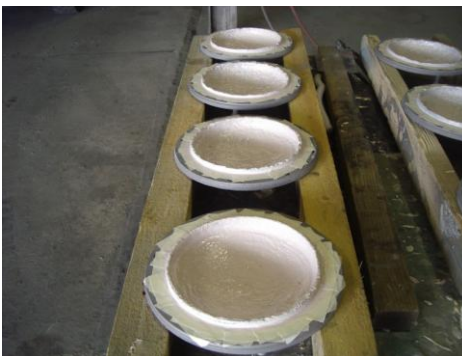
Covers after first coat with RB 332

- Abrasive blast to AS1627.4 Sa2.5 with a nominal surface profile of 75µm.
- Hot wash to reduce presence of metallic salts to <25ppm and re-abrasive blast.
- Application of RB 332

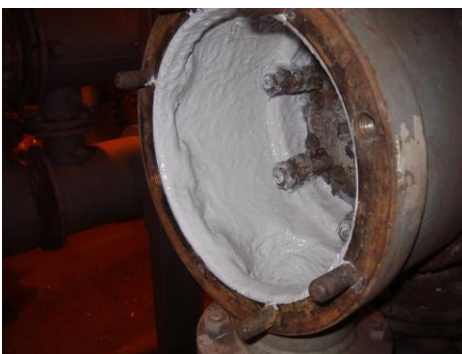
Water boxes after W/B, priming and application of RA 532

The first unit was coated in 2006 with an expected operating life of two years remaining due to plant redundancy. This unit has continued to remain online and in great condition for a substrate that is more than 60 years old. It is expected to last another ten years.

The newly coated water boxes were done without incurring costs for abrasive blasting, encapsulation and carried out with reduced downtime.
