Client: <i>ITT</i>	Industry: <i>Oil & Gas</i>
Scope: <i>Impeller Refurbishment</i>	Date: <i>June 2012</i>
Location: <i>Australia</i>	Product: <i>RB 300, RS 500P, RP 500</i>

A sea water process pump had a heavily corroded bronze impeller which required to be refurbished. The lead time on a new impeller was 12 weeks, therefore repairing the damaged impeller was the only option until the new impeller arrived. This project was carried out by Corrosion Control Services, Australia.

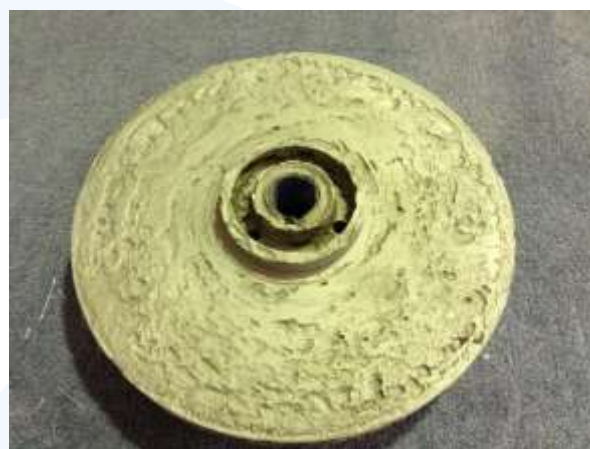
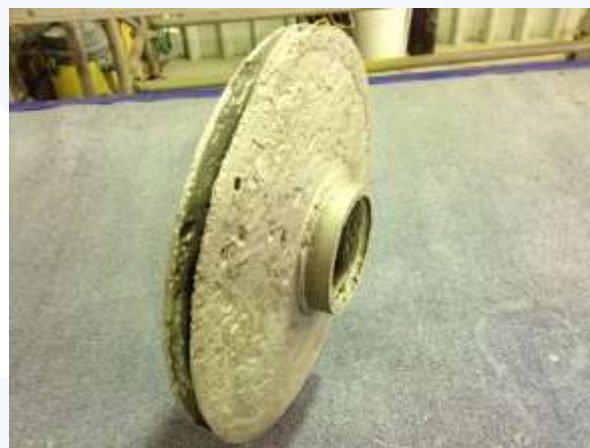
- Nos. 1-2 Before surface preparation

Upon blasting the impeller, there was severe material loss to the body and vanes. This project also had a very short time frame for completion, with a lot of rebuilding and shaping to perform.

Grit blasting the impeller to SA 2.5 standards to achieve a surface profile of 75µ. Utilise **Chem-tect™ RB 300 series** for priming and rebuilding the wear ring landings, vanes and body of the impeller. Upon completion of the rebuild, prime the impeller using **Epo-chem™ RS 500P @ 75µ DFT**, followed by a topcoat of **Ceram-chem™ RP 500 @ 400µ DFT**.

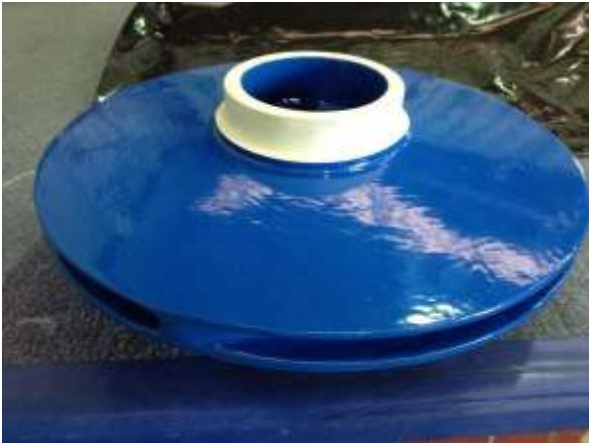
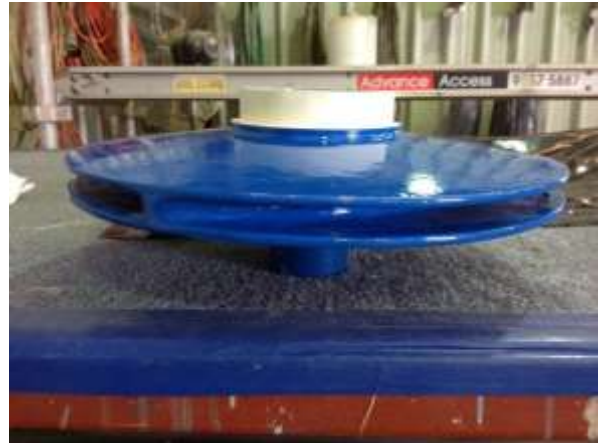
This project was completed within 4 days, much quicker than was anticipated by the client. The repair of the impeller utilising the **Chemco** system was so good that the repaired impeller is still in service after 18 months with the new impeller acting as a spare.

- Nos. 3-4 After surface preparation
- Nos. 5-6 During application process
- Nos. 7-8 Completed application
