# Case Study

<b>Client:</b> <i>Seadrill</i>	<b>Industry:</b> <i>Offshore</i>
<b>Scope:</b> <i>West Cressida Platform</i>	<b>Date:</b> <i>December 2012</i>
<b>Location:</b> <i>Thailand</i>	<b>Products:</b> <i>Epo-chem™ RL 500PF &amp; RC 500GTC</i>

In 2012, Chemco Speciality Coatings in Singapore were asked to provide a solution to refurbish the West Cressida platform as the existing coating system had failed.

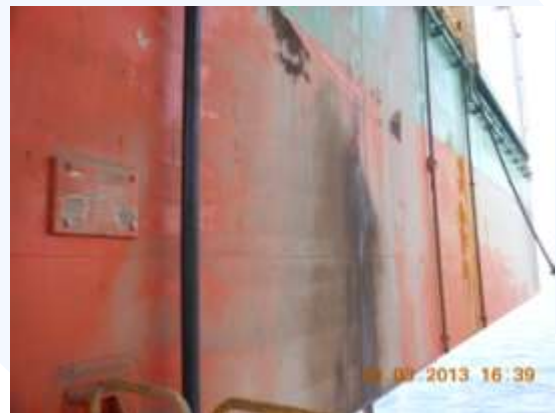
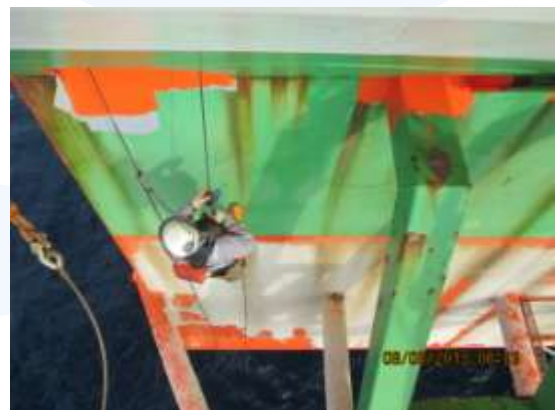
- Nos. 1 and 2 Existing failed coatings

A gondola system was used to access the ships hull. For the living quarter areas where the gondola system could not be accessed, rope access was used. With the rig being in operation, high pressure water jetting had to be used to remove the existing failed coating and rust. This process also removed the substantial sea growth and all salt contamination in one operation. One coat of wet & rust tolerant Epo-chem™ RL 500PF was applied, followed by one topcoat of Epo-chem™ RC 500GTC.

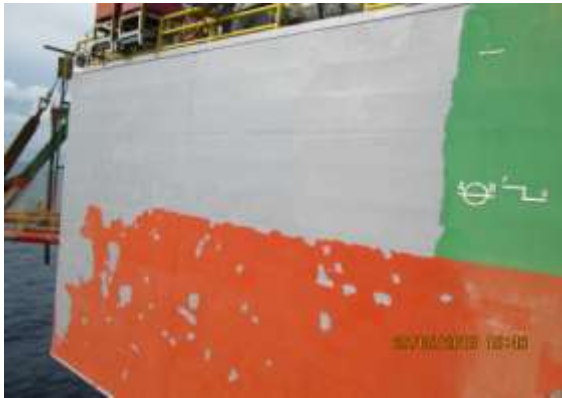
- No. 3 Priming stage on West Cressida's hull
- Nos. 4 and 5 Contrast between original failed coating and new high gloss topcoat
- Nos. 6 - 8 Completed application of Chemco system
