INTERNAL REPORT  
AIR INTAKE BELLMOUTH RELINING  
GT1&2  
SSE, KEADBY POWER STATION  
May – September 2012

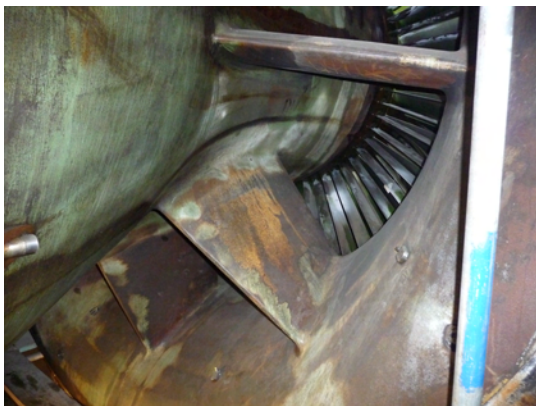
Picture 1 – Bellmouth prior to coating

For this work we initially agreed to carrying out the preparation on the Bellmouth using plastic blast media and using Dry Ice Blasting for the Silencer work. However the plastic media blasting was not successful and we had to resort to using garnet grit blasting to get a suitably clean surface with a profile on the Bellmouths. The Bellmouths had not been coated since new in 1996. However some touch up work was carried out on the Silencers where accessible. (See Picture 1)

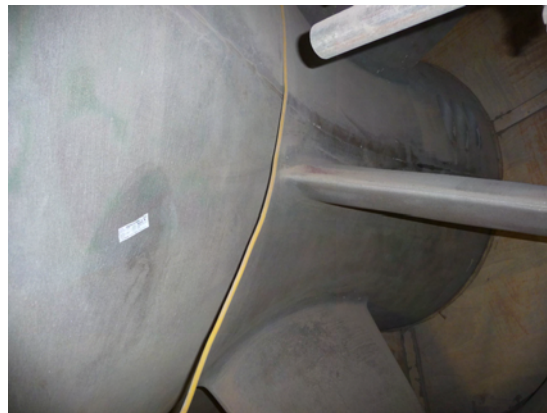
Picture 2 – Bellmouth after grit blasting

Changing to a coarse grade garnet ensured that the oil contamination was removed and a profile of a minimum of 75 microns was achieved. (See picture 2). Note the boarding sealing the air intake side of the Bellmouth from the turbine compressor. Additional protective sheeting was required on the acoustic cladding to the Bellmouth surround.

The change in preparation specification meant we had to redo the GT2 Bellmouth as the coating, that was initially applied, was peeling off. This was found to be where there was oil contamination of the casing that the plastic media had not been able to remove.

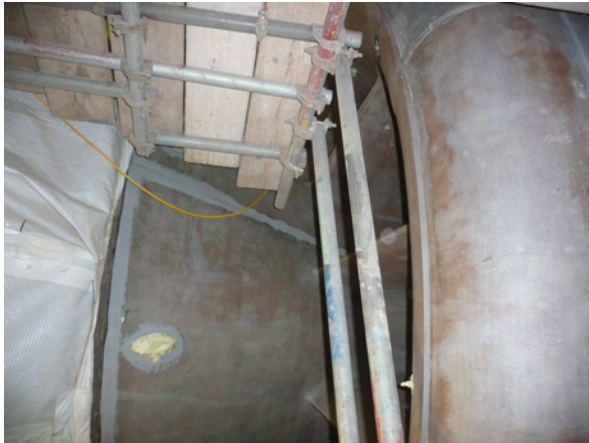
Picture 3 – Stripe coating RS 500P

After grit blasting and cleaning up the Bellmouth by vacuuming and wiping down with acetone the Bellmouth was coated with a single coat of CHEMCO Epo – chem RS 500P to a film thickness of approximately 100 microns. (See pictures 3 & 4) followed by a single coat of CHEMCO Epo – chem RA 500M to a film thickness of 200 – 250 microns, thus giving a total film thickness of approximately 300 – 350 microns. (See picture 5 & 6).

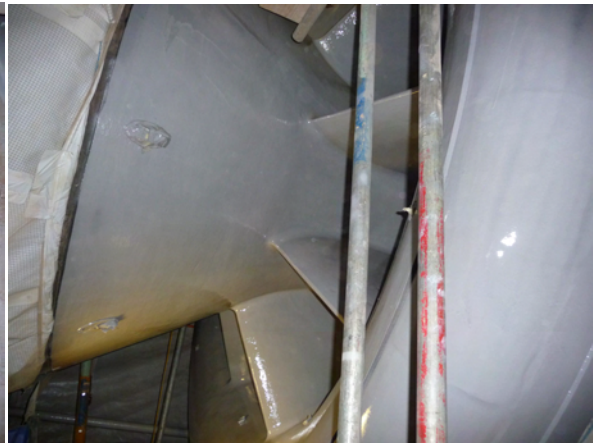
Picture 4 – completed coating RS 500P

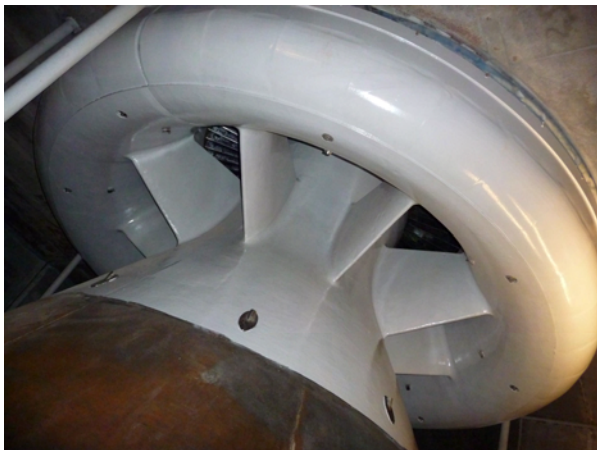
Picture 5 – completed topcoat RA 500M

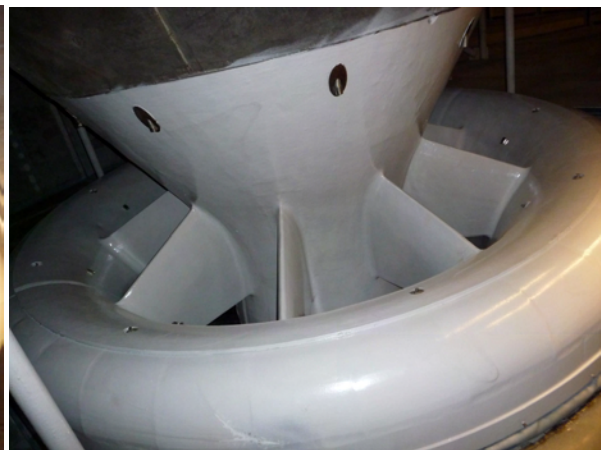
Picture 6 – Completed topcoat RA 500M
