INTERNAL REPORT
AIR INTAKE BELLMOUTH RELINING
GT1&2
SSE, KEADBY POWER STATION
May – September 2012

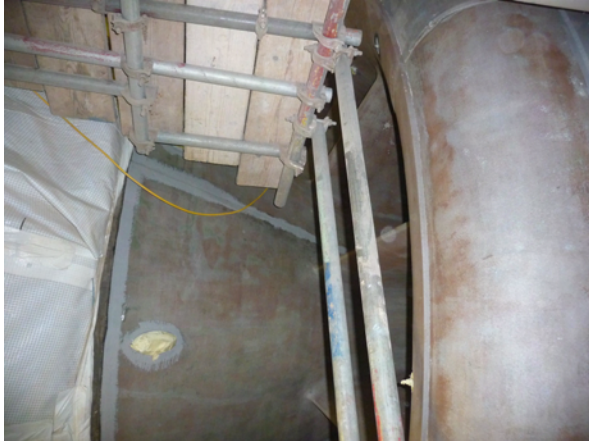
Picture 3 – Stripe coating RS 500P

After grit blasting and cleaning up the Bellmouth by vacuuming and wiping down with acetone the Bellmouth was coated with a single coat of CHEMCO Epo – chem RS 500P to a film thickness of approximately 100 microns. (See pictures 3 & 4) followed by a single coat of CHEMCO Epo – chem RA 500M to a film thickness of 200 – 250 microns, thus giving a total film thickness of approximately 300 – 350 microns. (See picture 5 & 6).

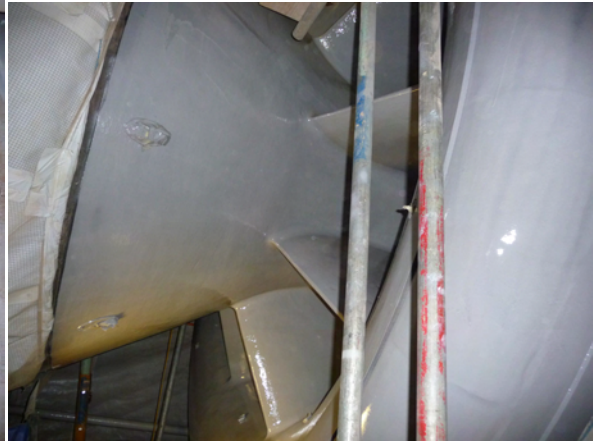
Picture 4 – completed coating RS 500P

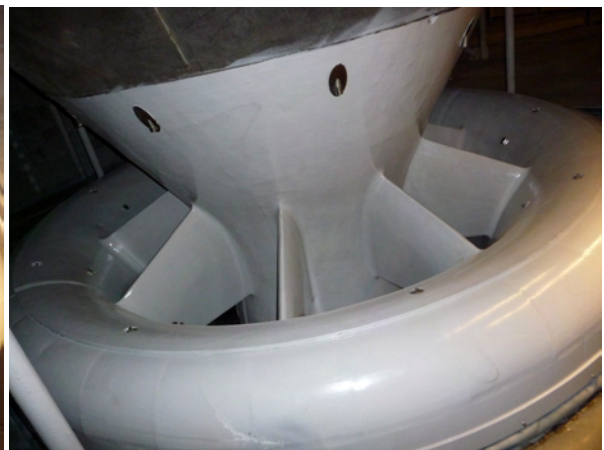
Picture 6 – Completed topcoat RA 500M
