# 500 Series Heat Exchanger Vessel

<b>Industry</b>	HVAC, Power Generation, Oil & Gas
<b>Date</b>	February 2012
<b>Substrate</b>	Cast Iron
<b>Products</b>	RS 500P, RA 532
<b>Environment</b>	Recirculated water

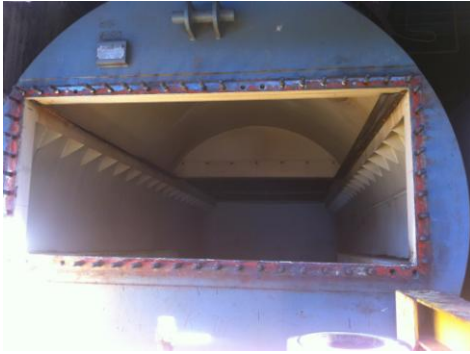
32 year old heat exchange vessel

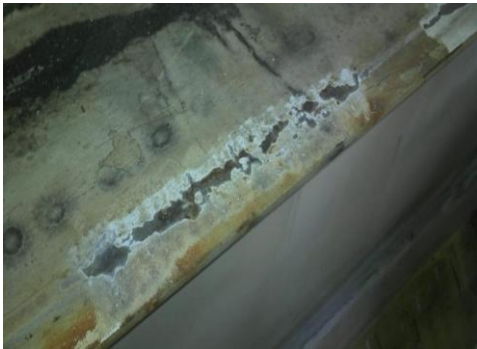
Mechanical damage with heavy pitting

**Challenge** The unit was manufactured in 1981 and installed shortly after. Fatigue cracking was found in some welds and localised corrosion was discovered on the tube bundle guides. Inclement weather was also a factor in determining the coating to use.

**Scope** Identify damaged areas and check existing specification thickness  
 Bristle blast surface area to be repaired  
 Solvent wipe and square off using masking tape  
 Application of RS 500P in one coat to a nominal DFT of 100µm  
 Application of RA 532 in one coat to a minimum DFT of 250µm

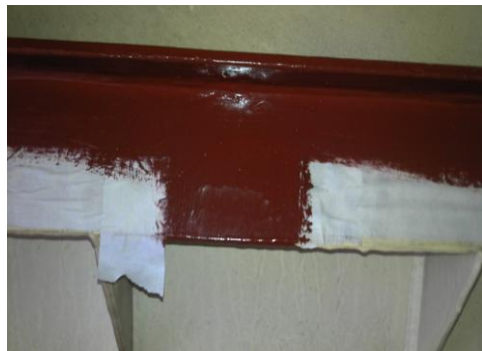
Application of RS 500P a wet & rust tolerant primer

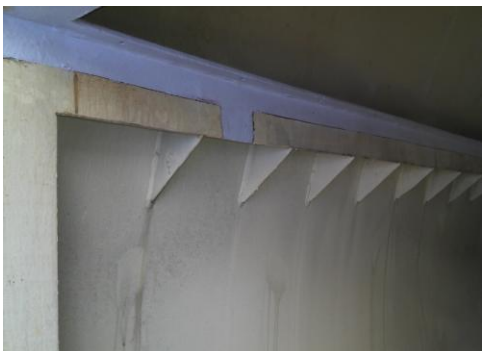
Application of RA 532 a wet tolerant glassflake filled epoxy
