500 Series for Steel Clarifier

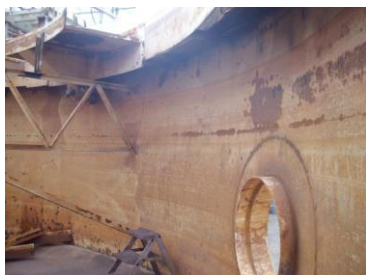
Before – Clarifier on inspection

Industry	Steel Manufacturing
Date	February 2009
Substrate	Failed coating causing steel structure to corrode
Products	Chemco Epo-chem™ 500 series
Environment	Immersed, ambient, treated process water
Challenge	The existing coating failed due to a process change. The time constraints required Chemco to work around the clock to minimise production downtime. The coating system had to be environmentally friendly as the work was to be carried out whilst other engineering teams were in close proximity. The adjoining plant remained in operation.

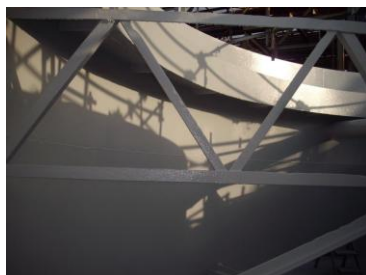
Launder and steelwork
