500 Series for Steel Clarifier

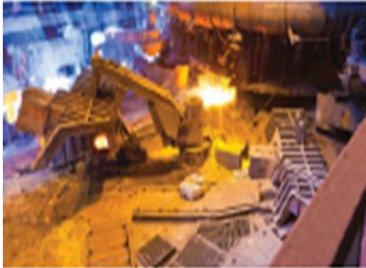
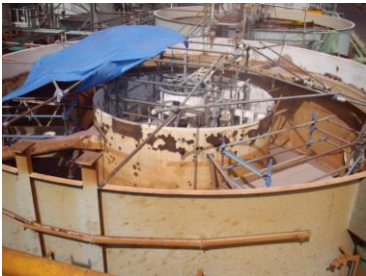
Before – Clarifier on inspection

Industry	Steel Manufacturing
Date	February 2009
Substrate	Failed coating causing steel structure to corrode
Products	Chemco Epo-chem™ 500 series
Environment	Immersed, ambient, treated process water
Challenge	The existing coating failed due to a process change. The time constraints required Chemco to work around the clock to minimise production downtime. The coating system had to be environmentally friendly as the work was to be carried out whilst other engineering teams were in close proximity. The adjoining plant remained in operation.

Chemco's Solution	We recommended the solvent-free, low odour Epo-chem™ 500 series for the corroded clarifier; a coating system that has a life expectancy of over 25 years. This system comprised of a wet & rust tolerant MIO ZINC primer - Epo-chem™ RS 500P plus an epoxy resin filled with screened glassflake - Epo-chem™ RA 532 as the final protective barrier.
--------------------------	--

Results	As a result of the fast cure time, the clarifier was back in service within 76 hours. Our trained and experienced applicators paid attention to detail on all edges and weld zones. The customer was extremely satisfied with the completed job and pleased that Chemco was able to complete it on time and within budget.
----------------	--

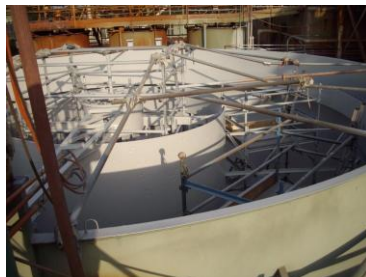
Coated with Epo-chem™ 500 series

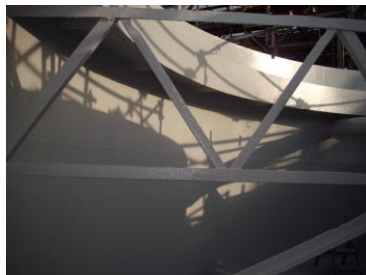
Launder and steelwork
