<b>Client:</b> <i>Jamaica Energy Partners</i>	<b>Industry:</b> <i>Marine</i>
<b>Vessel:</b> <i>Dr Bird Generator Barge No.1</i>	<b>Date:</b> <i>May 2009</i>
<b>Location:</b> <i>Jamaica</i>	<b>Products:</b> <i>Epo-chem™ RA 500M &amp; RS 5000P</i>

The Dr Bird Generator Barge (No.1) provides around **15% of Jamaica's electricity**. Under the Local Authority and Classification Legislation of Jamaica, the Barge had to undertake a major overhaul of steel replacement and re-coating works (over 8,000m<sup>2</sup>) in the ballast tanks to achieve class.

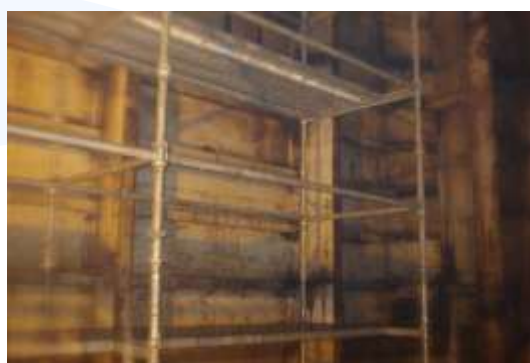
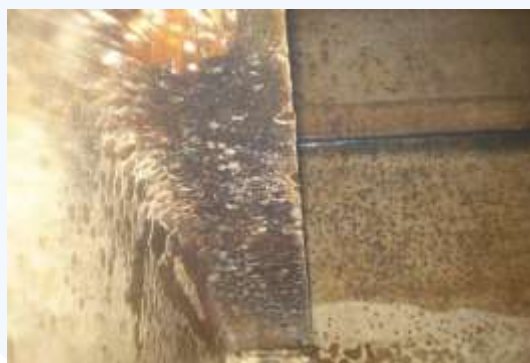
- Nos. 1 and 2 Ballast tank before application
- Nos. 3 and 4 Preparation in progress
- No. 5 RS 500P primer partly applied
- Nos. 6 and 7 Ballast tank after application

Following high pressure washing to WJ-3 (800 bar) **Epo-chem™ RS 500P solvent-free, rust & wet tolerant** primer was applied to a DFT of 100µ. This was followed by one coat of **Epo-chem™ RA 500M solvent-free, wet tolerant** glassflake epoxy @ 200µ. Total DFT 300µ.

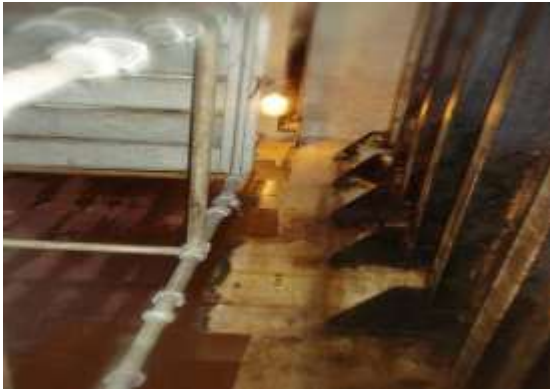
- No. 4 Preparation in progress
- No. 5 RS 500P primer partly applied
- Nos. 6-7 Ballast tank after application
