<b>Client:</b> <i>Major Shipping Company</i>	<b>Industry:</b> <i>Marine</i>
<b>Vessel:</b> <i>Crude Oil Tanker</i>	<b>Date:</b> <i>July 2017</i>
<b>Location:</b> <i>China</i>	<b>Products:</b> <i>Epo-chem™ RS 500P</i>

## Overview

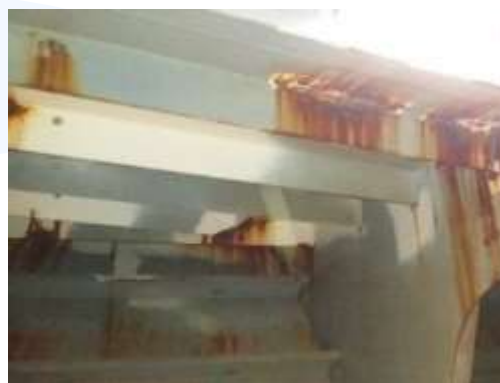
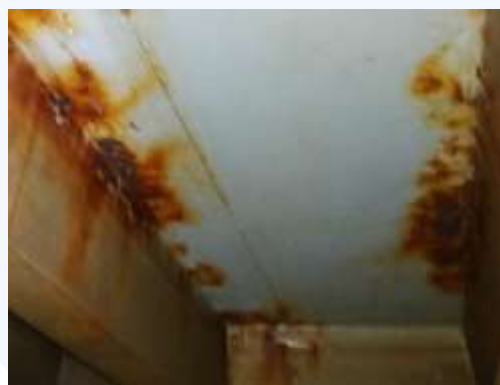
The original coating located in the water ballast tanks onboard the crude oil tanker was showing considerable wear & tear damage in the form of corrosion. The tanks therefore had to be refurbished.

- Nos. 1-2 Original Conditions
- No. 3 After Water Jetting

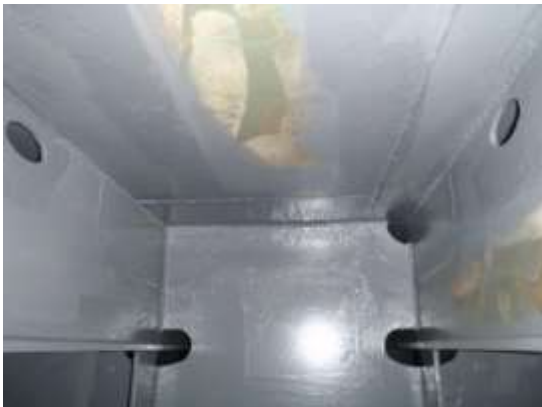
- No. 4 Completed Application
- No. 5 Chemco Coating After 1 Year
- No. 6 Conventional Coating After 1 Year

The tanks were water-jetted to WJ-3 standard before one stripe coat and one full coat of **solvent-free, wet & rust tolerant epoxy Epo-chem™ RS 500P** were applied.

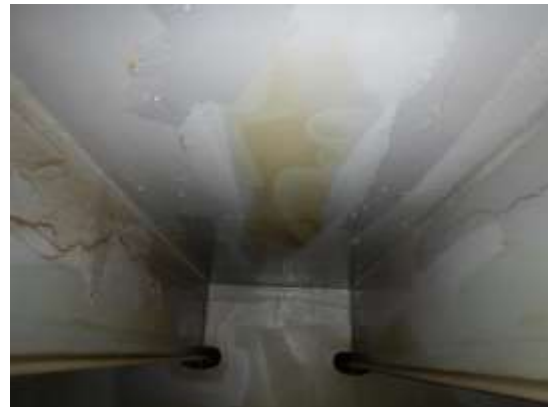
5

After **1 year in-service (August 2018)**, the ship management company carried out tank inspections and found a clear difference in quality between the tanks coated by Chemco, and those coated by the separate manufacturer. The conventional paint system was failing after only **1 year, whereas Chemco's RS 500P** remained in very good condition.
