Client: <i>BP</i>	Industry: <i>Petrochemical</i>
Scope: <i>Crude Oil Tank</i>	Date: <i>November 2008</i>
Location: <i>BP Kinneil (Tank 3701)</i>	Products: <i>Epo-chem™ RA 564</i> <i>Ceram-chem™ RH 500</i>

The internal floor area and 2m up the walls of a large diameter tank holding crude oil, required to be completely refurbished in a limited timescale during the plant shutdown. There was also a requirement for a long-term corrosion system that would last until the tank re-opened again in 10 years time. This project was carried out by Hertel.

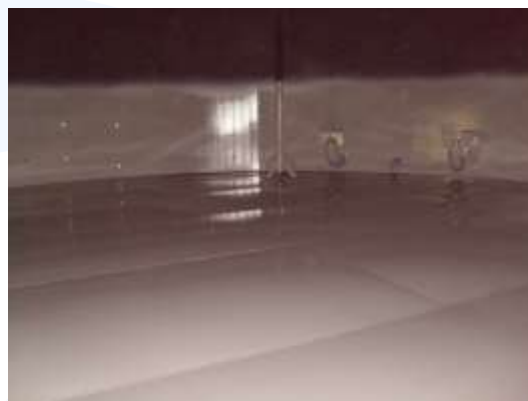
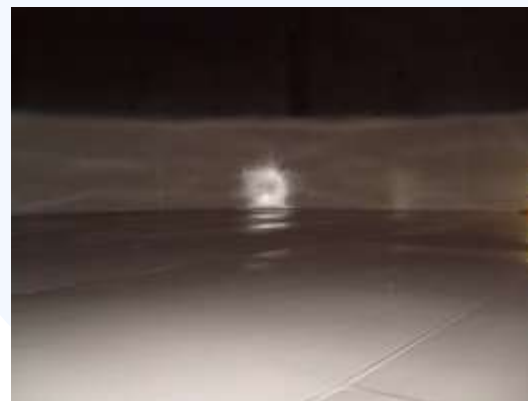
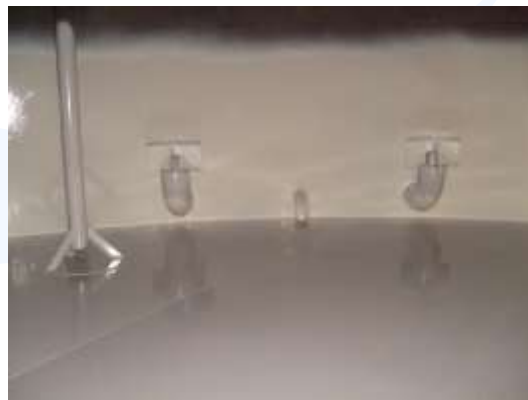
- Nos. 1-3 Application complete

First coat of **Epo-chem™ RA 564 solvent-free** glass-flake epoxy system @ 500µ DFT by airless spray. All deep pitting were filled with **Ceram-chem™ RH 500 solvent-free**, ceramic epoxy putty. Second coat of **Epo-chem™ RA 564 solvent-free** glassflake epoxy system @ 500µ by airless spray.
Total DFT: 1,000µ

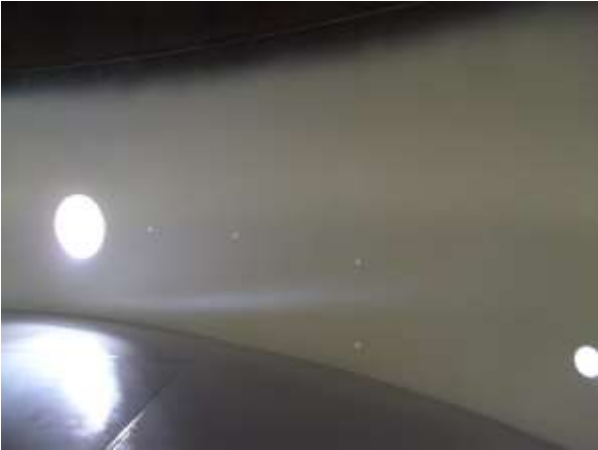
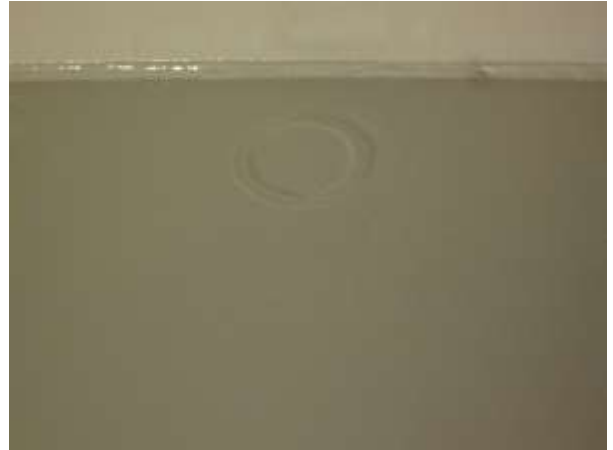
- Nos. 4-5 Application complete
