# Case Study

<b>Client:</b> <i>Hanson Marine</i>	<b>Industry:</b> <i>Marine</i>
<b>Vessel:</b> <i>Dredger</i>	<b>Date:</b> <i>May 2013</i>
<b>Location:</b> <i>Antwerp, Belgium</i>	<b>Products:</b> <i>RS 500P &amp; Chem-glide™ RA 500CG</i>

## Overview

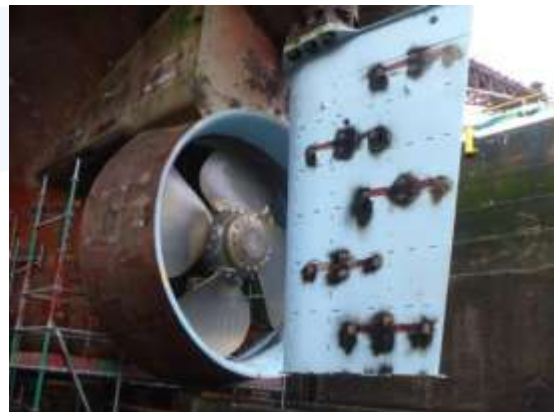
- No. 1 After 18 months in service
- Nos. 2 and 3 Completed application

The vessel was brought to dry-dock with the Chemco system and a major top-selling anti-fouling being in operation for 18 months. After HP cleaning, the Kort nozzle and rudder were in 'as good as new' condition. The only maintenance requirements were small touch-up areas where mechanical damage had occurred. The half of the rudder coated with an industry leading anti-fouling was showing signs of extensive fouling and corrosion damage. This conventional system also lifted from the surface of the hull during cleaning, resulting in high maintenance costs for repair.

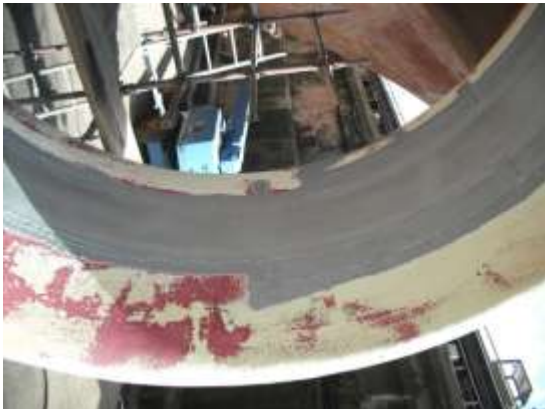
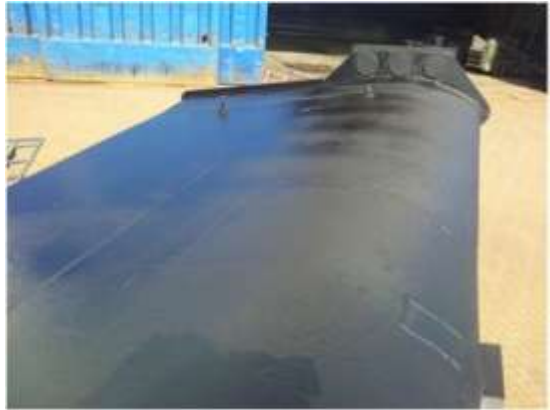
- Nos. 4 and 5 After surface preparation
- Nos. 6 and 7 After priming with **Epo-chem™ RS 500P**
