<b>Client:</b> <i>Harrogate Hotel</i>	<b>Industry:</b> <i>Industrial</i>
<b>Scope:</b> <i>Potable Water Tank Repair</i>	<b>Date:</b> <i>January 2012</i>
<b>Location:</b> <i>UK</i>	<b>Product:</b> <i>Epo-chem™ RS 500P &amp; RA 500M</i>

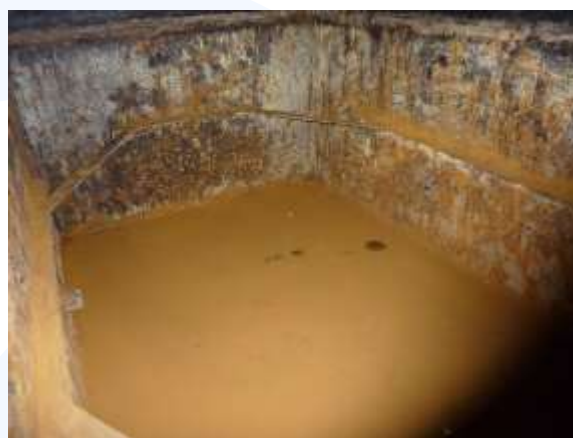
The tanks were extremely rusty and deeply pitted. Working in very cold conditions and within a strict timeframe added to the difficulty of this project.

- Nos. 1 and 2 Before application

Manual preparation was selected as the surface preparation method. One primer coat of **solvent-free, wet & rust tolerant Epo-chem™ RS 500P** was applied first. This was followed by two topcoats of **solvent-free, wet tolerant Epo-chem™ RA 500M**.

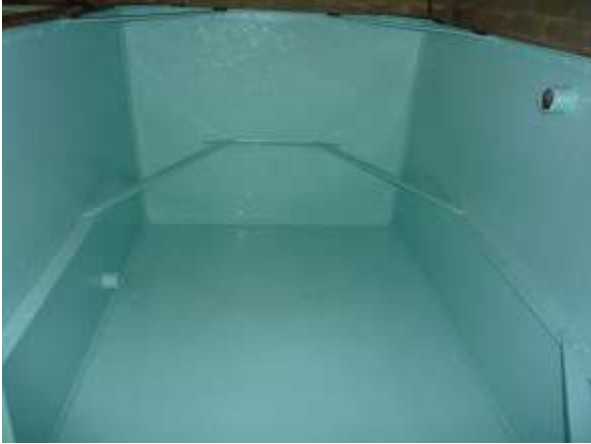
- Nos. 3 and 4 Completed application
