<b>Client:</b> <i>Tills Innovations</i>	<b>Industry:</b> <i>Industrial</i>
<b>Scope:</b> <i>Water Feature Externals</i>	<b>Date:</b> <i>January 2017</i>
<b>Location:</b> <i>UK</i>	<b>Product:</b> <i>RA 500M, RH 500 &amp; RC 500GTC</i>

## Overview

The existing coating had blistered as a direct result of an incorrect coating specification for an immersed environment.

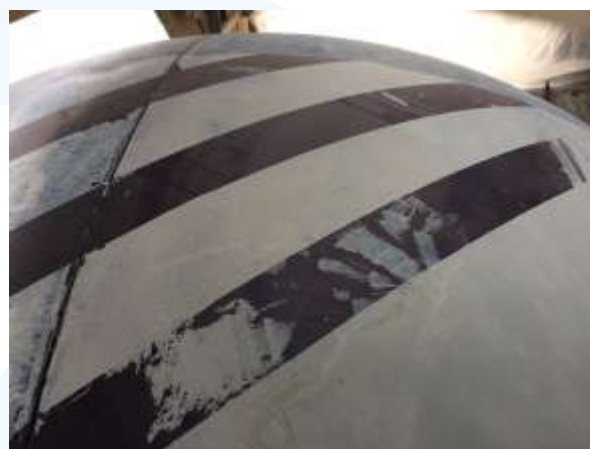
1

The existing coating had to be completely removed as it had failed and was showing poor adhesion to the substrate. The project also had to be completed within a short time frame given by the client.

- Nos. 1-2 Before Application

The surfaces were prepared by sponge blasting. This was followed by one coat of **solvent-free, wet tolerant epoxy Epo-chem™ RA 500M**. **Ceram-chem™ RH 500** was then applied to all pitted areas. To complete the coating application, two coats of high UV and chemically resistant epoxy acrylic topcoat **Epo-chem™ RC 500GTC** was applied.

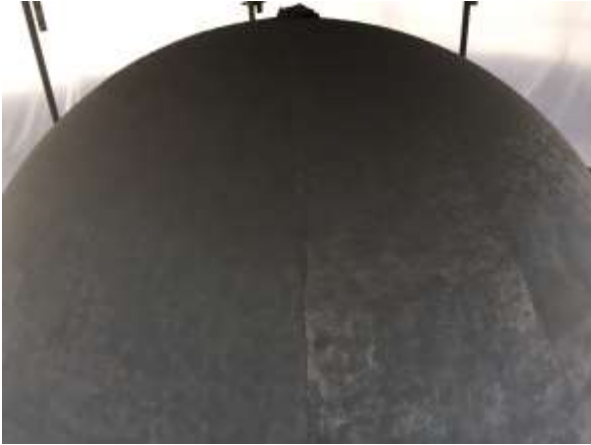
3

- Nos. 3-4 Before Application
- Nos. 5-6 Completed Application
